Soil and Groundwater Remediation Using Horizontal Wells

Watrous, New Mexico

HIGHLIGHTS

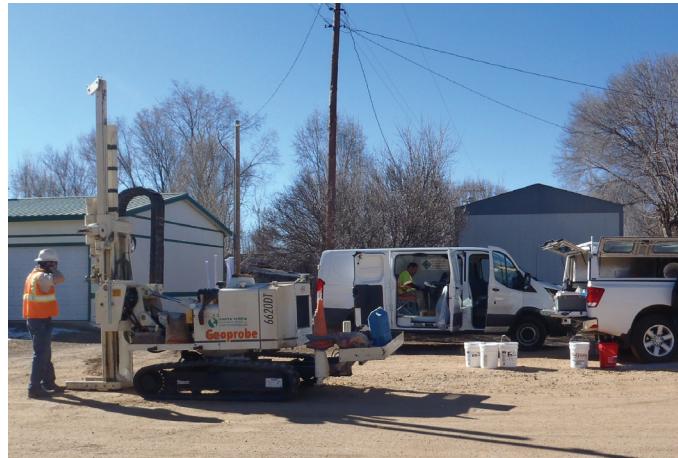
DBS&A performed geochemical analysis of groundwater in the field, which allowed us to focus and optimize our long-term sampling strategy.

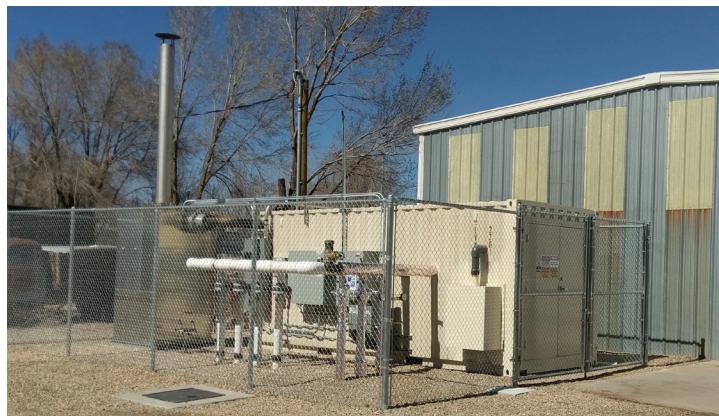
DBS&A is the local expert on utilizing horizontal remediation wells to expedite site remediation.
